Proving the Facts through Close Range Photogrammetry

By Lee DeChant,
DeChant Consulting Services – DCS Inc

This article investigates an actual accident where a metro bus hit a woman. The woman was standing on the sidewalk when an articulated bus approached a bus stop. CRP software was used to measure photographs taken at the scene, and to prove whether the bus driver was responsible for hitting the woman as the bus approached, or whether the woman actually stepped over the curb onto the street, hence no fault of the driver.

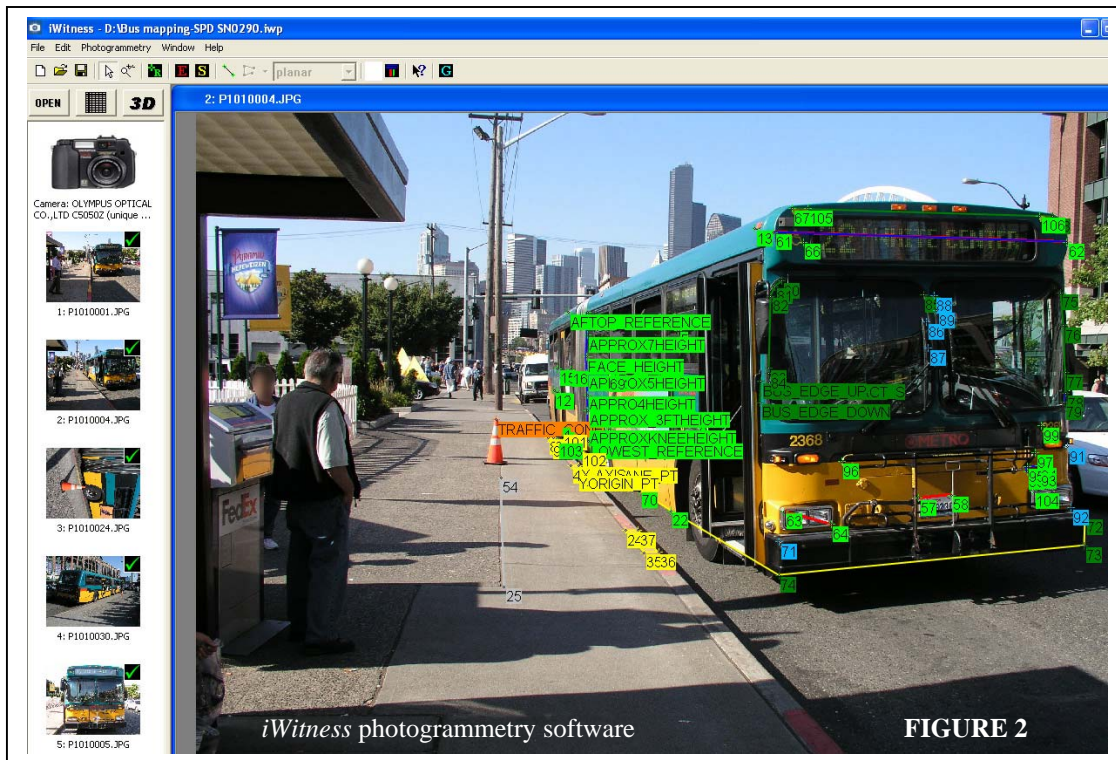
The photogrammetrist measured the front and the passenger side of the bus from the police digital images, as well as the aft-articulated section of the bus, as shown in Figure 2.

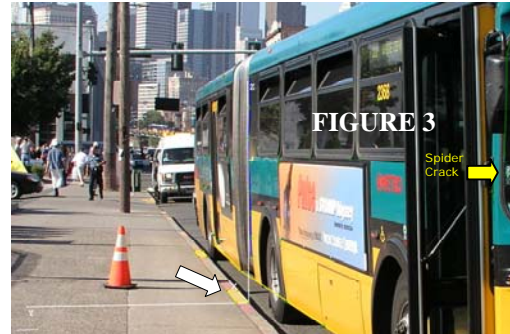
In addition, four key photogrammetric points (as indicated by the white arrow in Figure 3) were measured on the top surface of the curbing close to where the impact occurred.

Figure 4 illustrates the extruded 'monolith' from the four points on the curb; the same location as indicated by the white arrow in Figure 3.

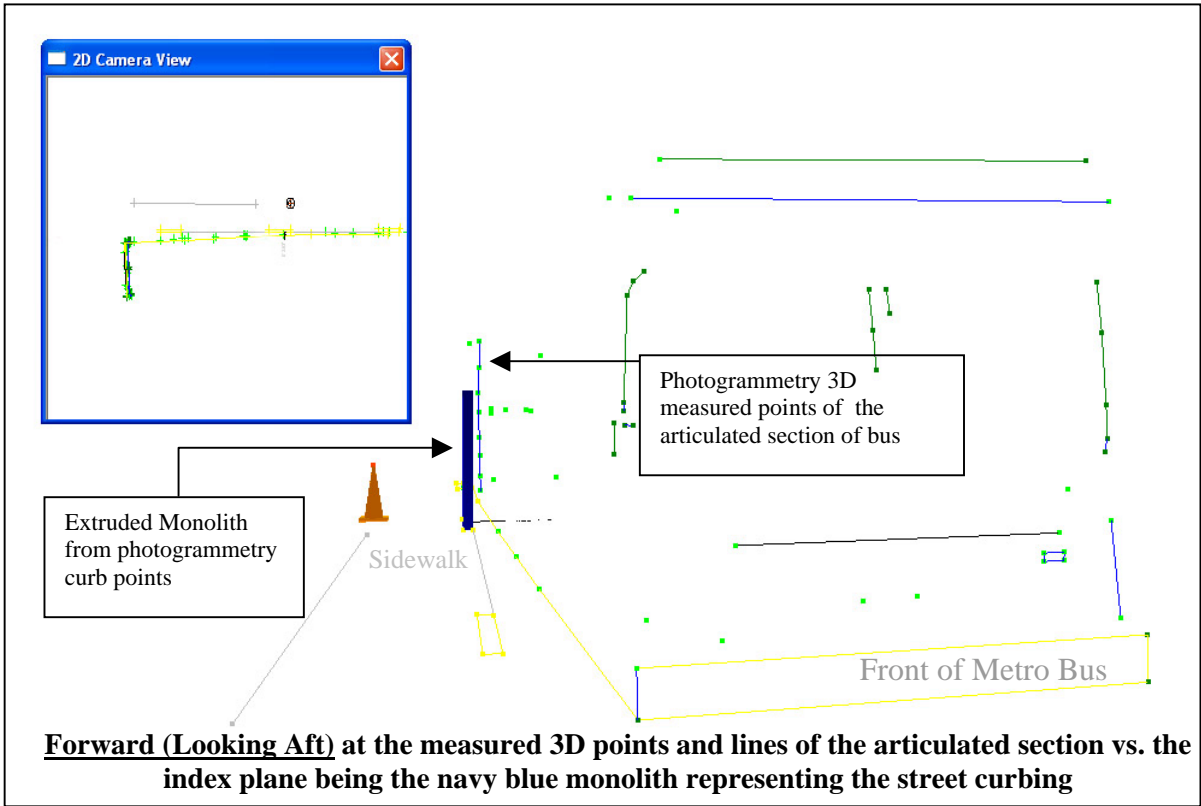
FIGURE 4

These points established the photogrammetric coordinate system by defining the curb's horizontal plane. This plane was extruded upwards in a CAD model – and this appears as a solid blue "monolith" in Figure 4. This monolith provides a three-dimensional vertically extended plane directly over the sidewalk/curbing and perpendicular to the street space.

The photogrammetric measurements of the bus, relative to the sidewalk and curbing, prove the woman must have had her body leaning over the curb and into the street space.

The measurements, when imported into the CAD program, revealed the woman's face was at least three inches into the street space, hence the reason she was struck by the bus.

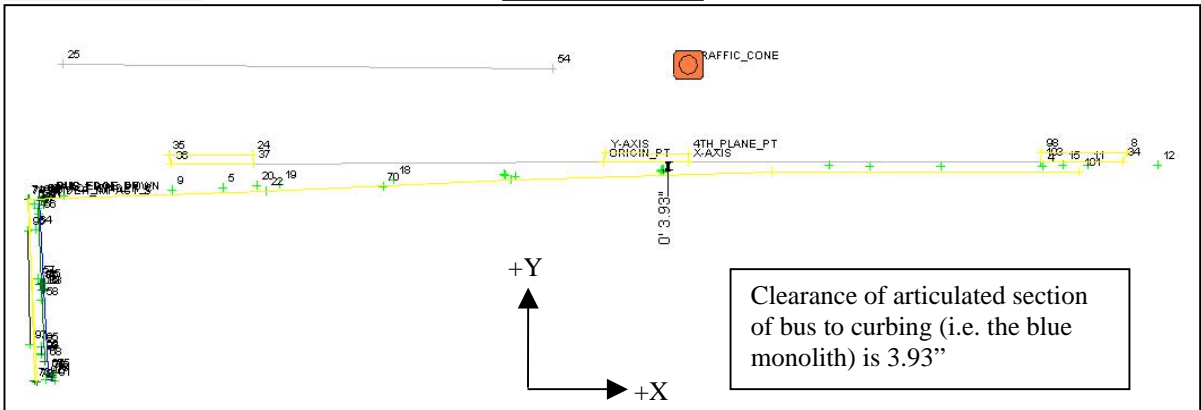
FIGURE 5

Plan View
