**Validation crash with a vehicle striking another car
pulling a trailer with a boat**

iWitness close range photogrammetry and
Nikon AIMS total station. Time and 3D points
comparison

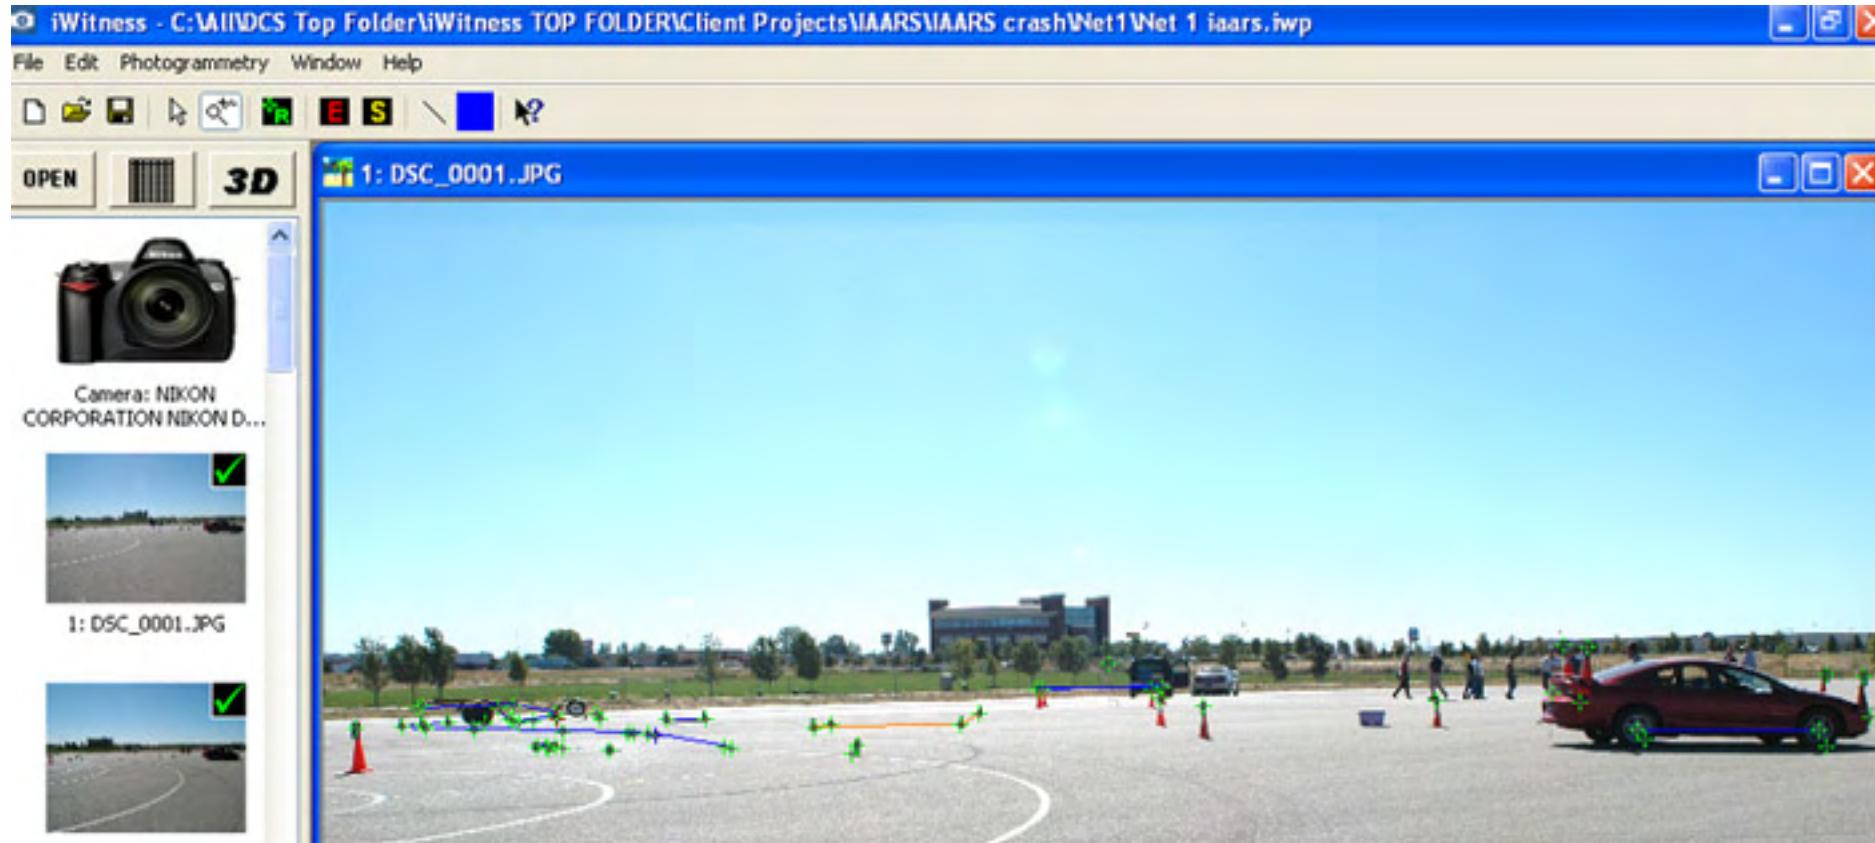
Scene overview of post collision. Bullet car #2 center, #1 tow car on right, boat trailer and crash evidence on left. iWitness 3D point marking illustrated with lime green "+" marks.

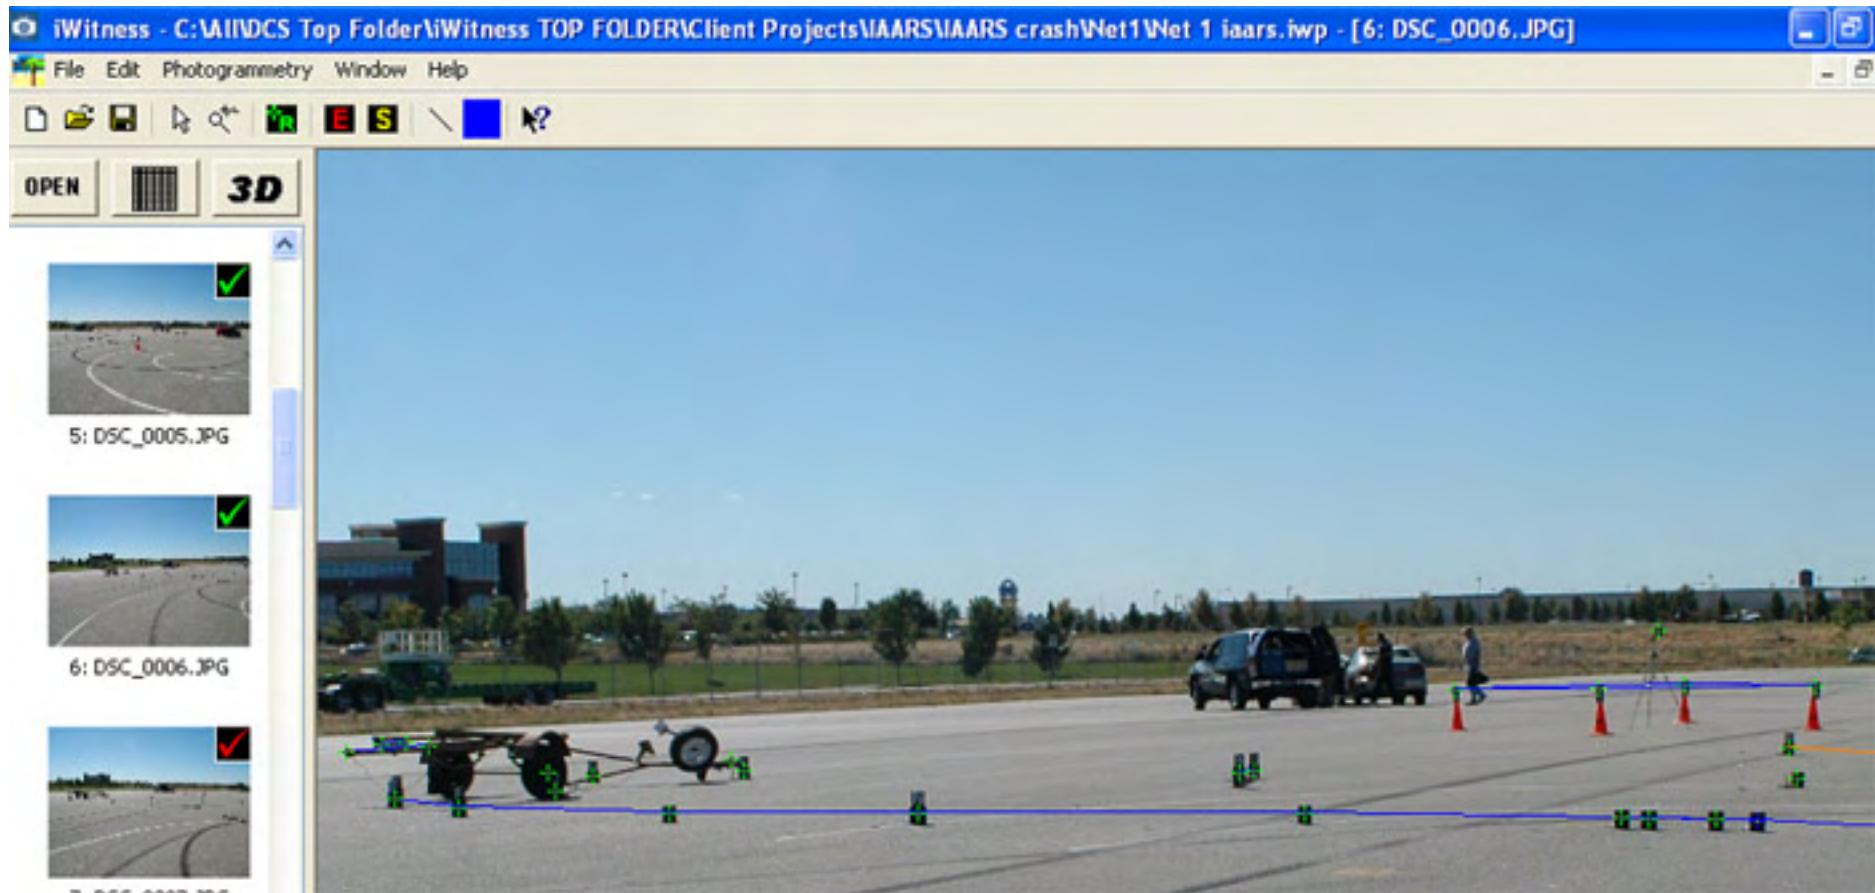
Expanded view of trailer scuff marking, and trailer final rest.

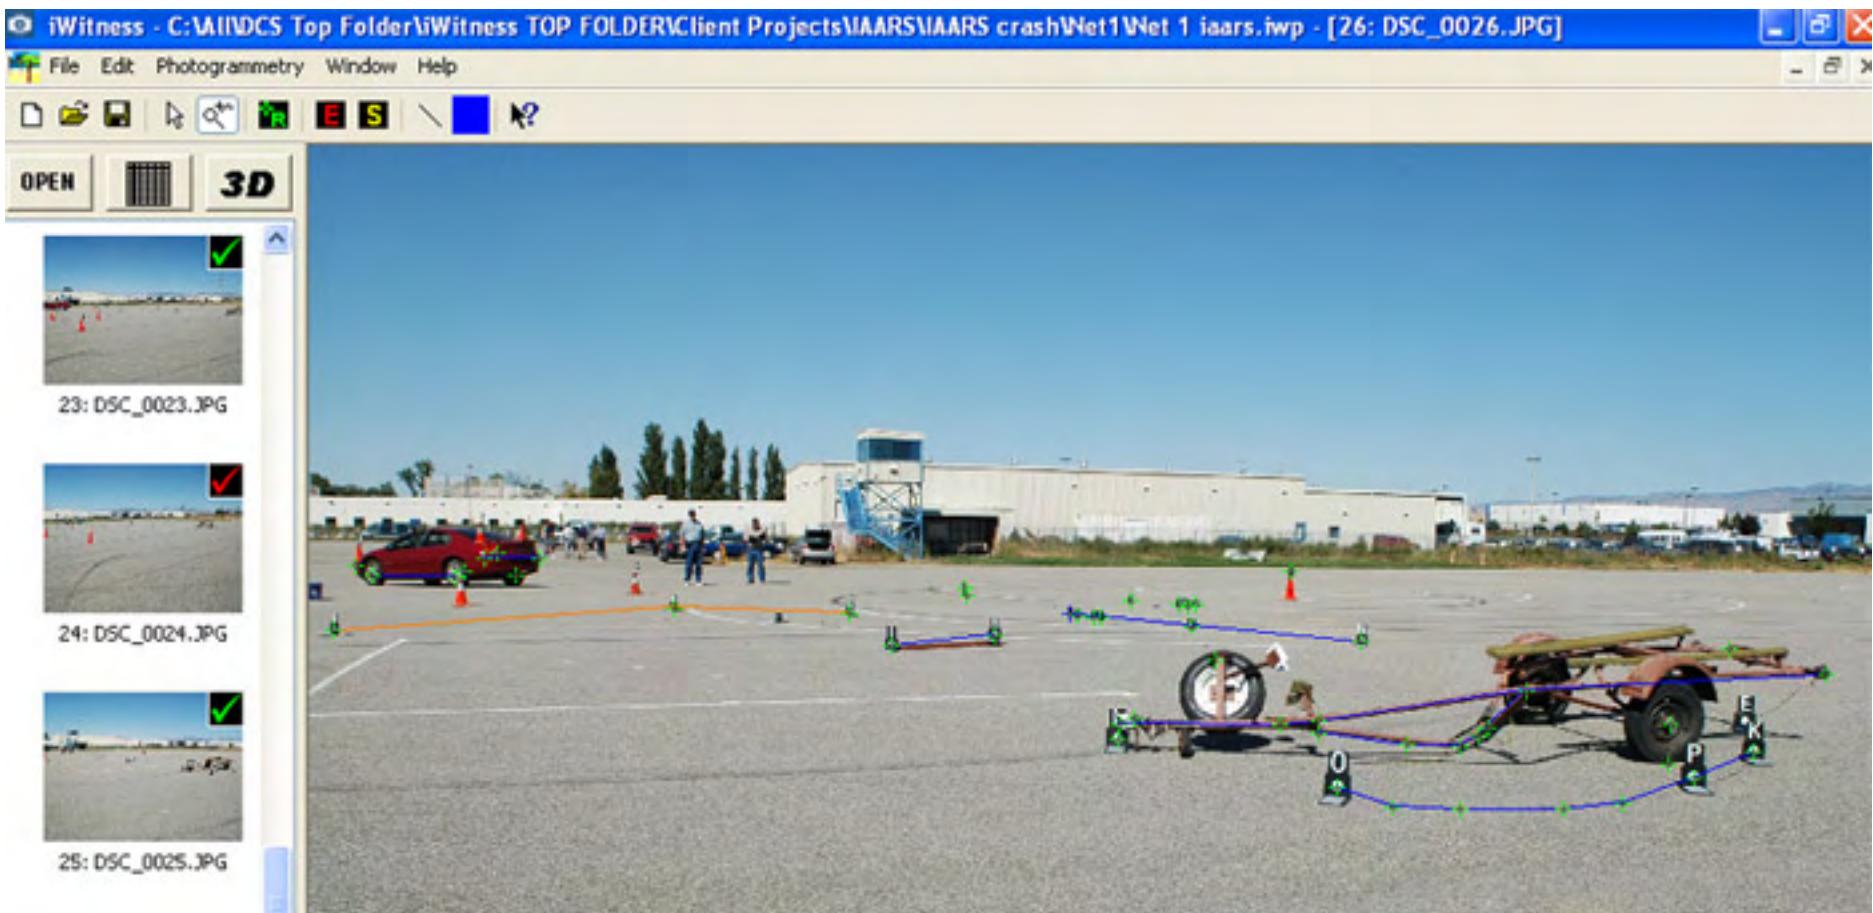
Reverse image of tow car, and boat trailer.

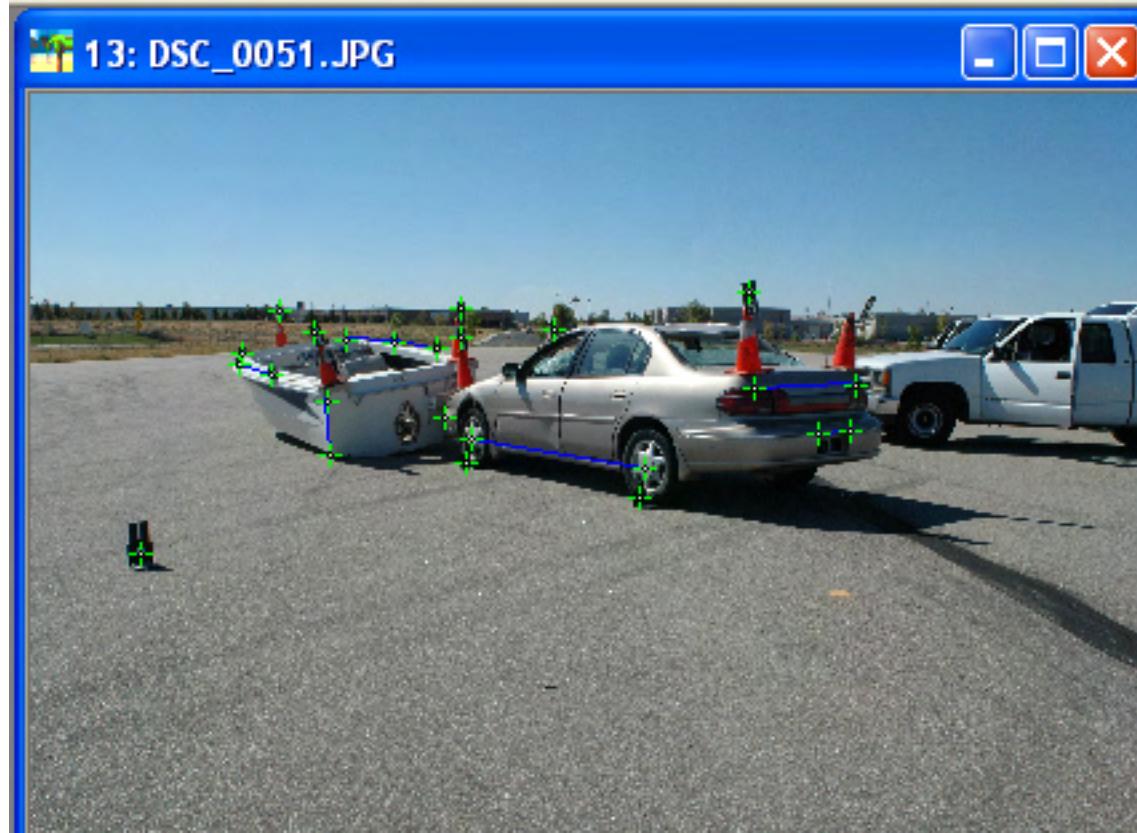
The boat disengaged the trailer from bullet vehicle impact and rode on top of the bullet car for about 150', and then slide off the car's roof, to it's final rest position as noted above.

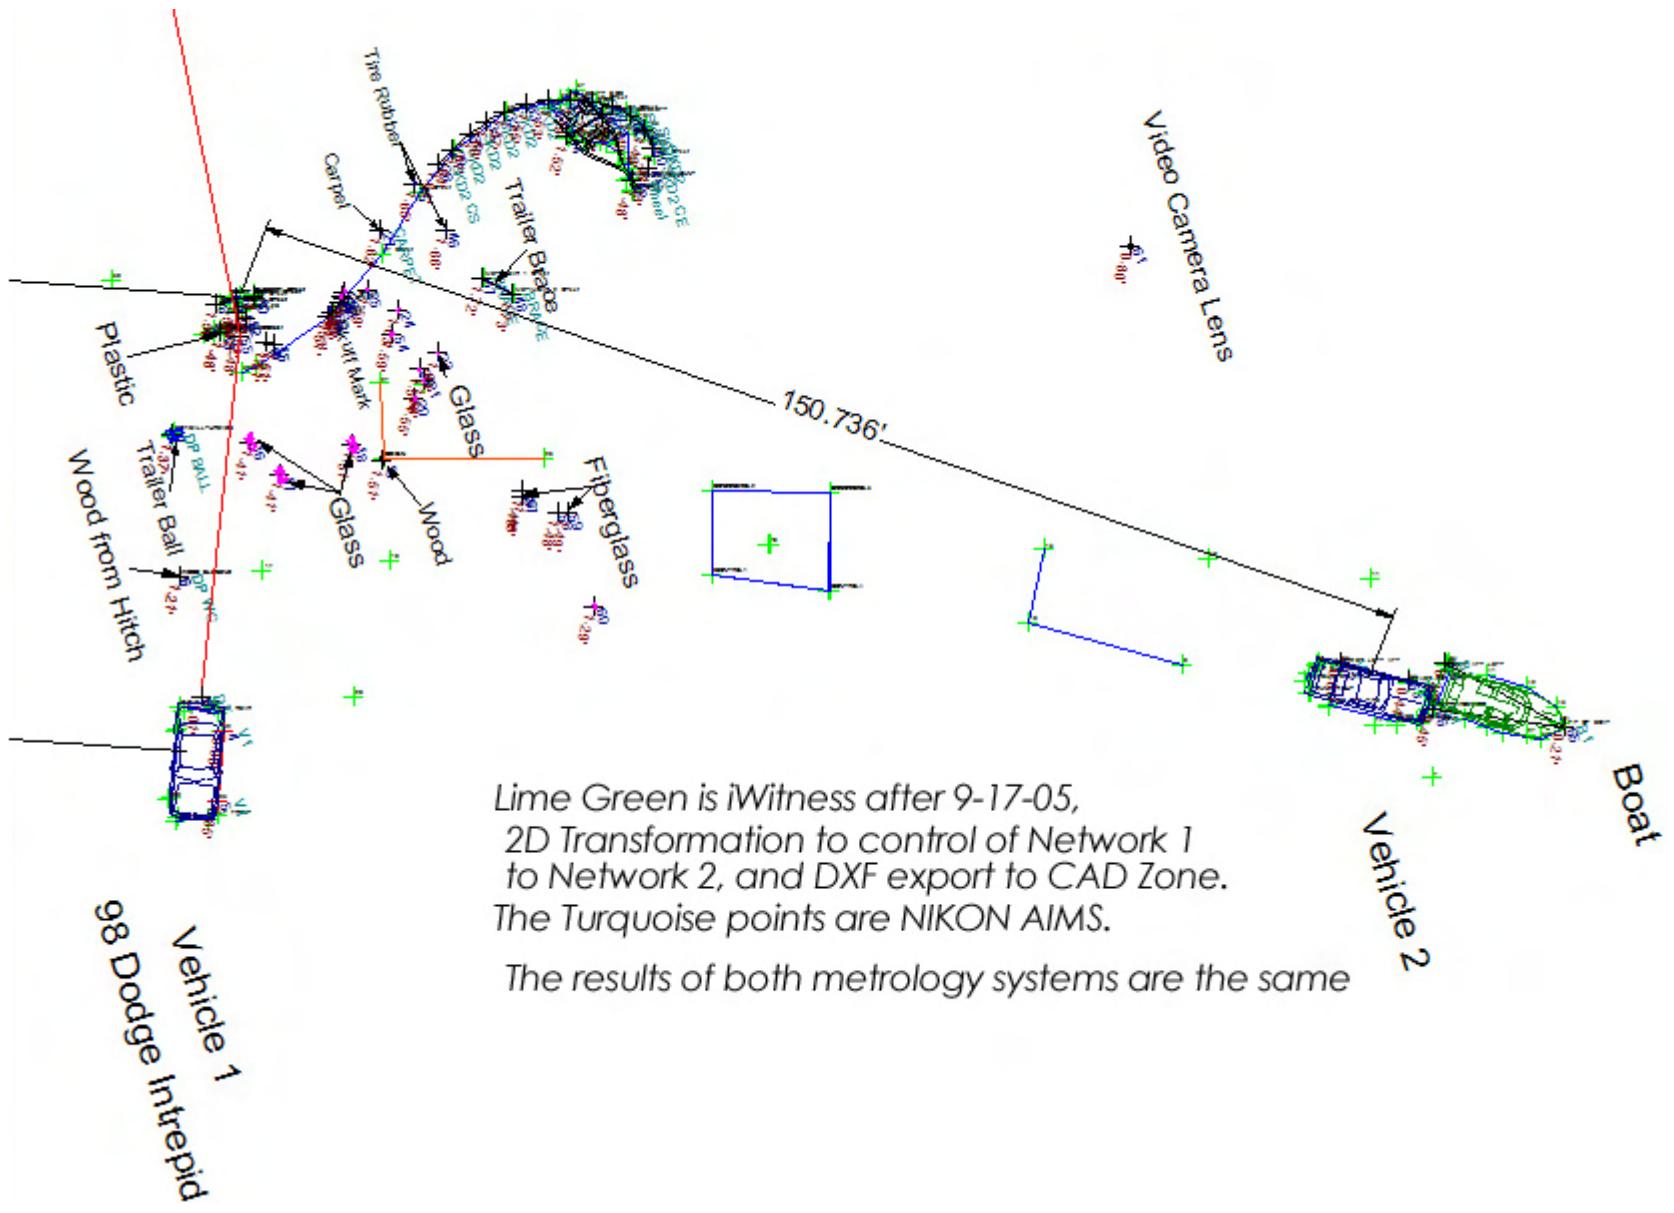
The DXF output overlay was made in The Crash Zone, accomplished on 9-17-5. The two metrology systems 3D data points are essentially identical.

- Independent time keeper noted the Total Station took 60 minutes to document the crash.
- Total Station operator noted 70 points were measured.
- Independent time keeper noted the Photogrammetry took 28 minutes to document the crash.
- iWitness photogrammetry operator noted 144 points were measured.
